A SYSTEMS-BASED APPROACH TO DEEPLY EXAMINE A DOWNGRADE-TRUCK CRASH CAUSED BY A BRAKE FAILURE IN VIETNAM

Do Duy Dinh^{a,*}, Vu Hoai Nam^a

^a*Faculty of Bridge and Road Engineering, Hanoi University of Civil Engineering,
55 Giai Phong road, Hai Ba Trung district, Hanoi, Vietnam*

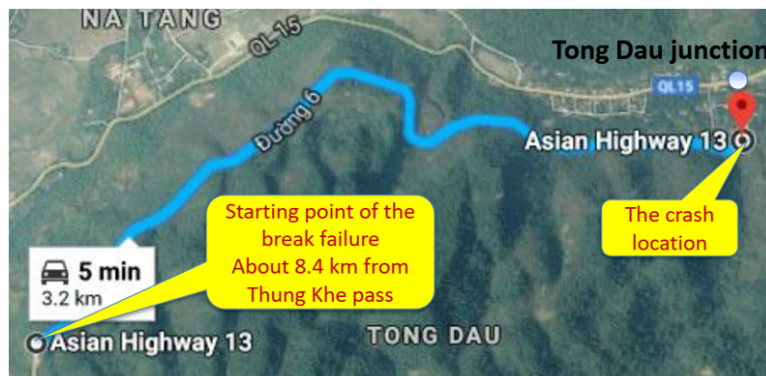
Figure 2. The road section before the crash location

The crash under examination occurred on a road section of the National Highway No.6 (NH6; also known as Asian Highway 13) located in a mountainous region of Hoa Binh province, Vietnam. The crash happened at the end of the road section of a continuous and long downgrade hill that contains various sharp horizontal curves. The starting point of this downgrade section is the Thung Khe mountain pass which is approximately 11.6 km far from the crash's location. The crash involved a truck traveling down from the pass at high speed, having, at some points, defective use of the brakes. After trying to navigate a series of curves including a number of sharp curves, this goods vehicle collided with a passenger car in front on the last curve of the road section. Based on the truck driver interviews and on-scene investigations, the location where his truck experienced a brake malfunction was ascertained to be approximately 8.4 km from Thung Khe pass (3.2 km from the crash site) as shown in Fig. 2.

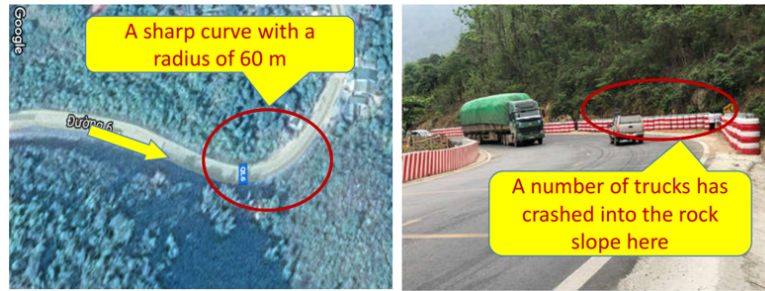
Figure 3. The location of the crash

After the collision, the truck drove the passenger car to the roadside safety barriers on the right-hand side. As shown in Fig. 3, the barriers were constructed by deposited rubber wheels and a steel frame. The truck then jumped over the car and a part of its body slid on the top of the barriers until it turned over on the carriageway. The crash made the car severely damaged, however fortunately, individuals involved in this crash (i.e., the truck driver, the car driver, and the car passengers) survived, though their injuries were rather serious.

The tire wall, i.e., the roadside barriers constructed by deposed wheels and steel frame, which is an initiative of the DRV in response to the safety issue of the road section, worked quite effectively in the accident. If the barriers were not installed, the accident may have been considerably more serious; however, the tire wall still did not completely eliminate injury, suggesting that improvements could be made. With regards to the truck's characteristics, firstly the truck does not have any mechanism to cope with brake failure, despite it being a well-known issue. Secondly, the truck driver said that he was not able to shift from a high gear to a low one, due to the functioning of the pneumatic system controlling both brakes and gear changes. Add to this is the non-functioning of the air horn, being operated by that very same pneumatic system, and other road users could not be alerted to the situation the driver was facing. Thus failure in one underlying system meant the removal of two possible avenues for incident consequence reduction (namely deceleration through gear change and increased noticeability through horn use).

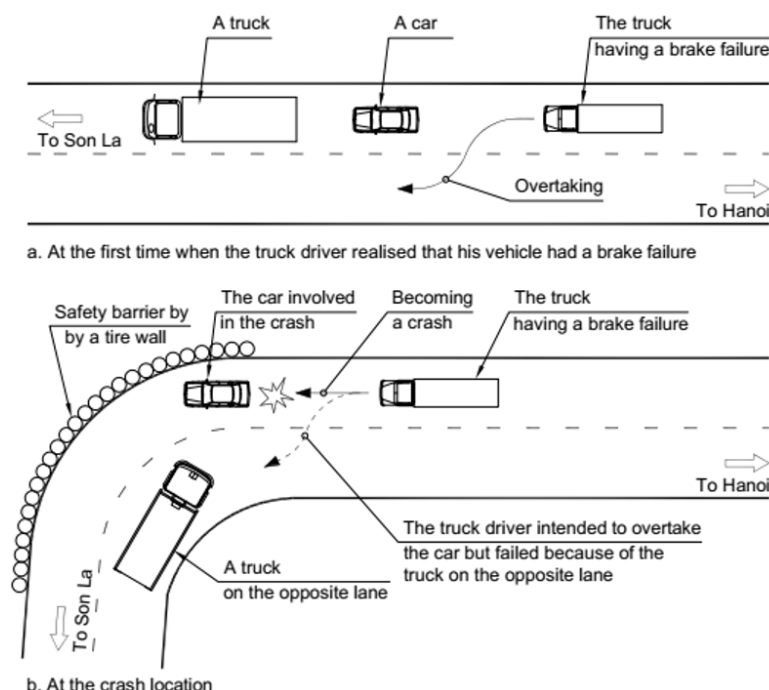
Figure 4. The diagram describing the location of the truck involved in the crash at some time points

As shown in Fig. 4, at the time the truck driver perceived that the truck had a brake malfunction, his vehicle followed a car and another truck with a short distance between these vehicles. He continued to maneuver his vehicle using high gear and, along with the car, overtook the truck going ahead of him. The truck driver realized that switching to a low gear should be a possible way to use the vehicle engine for decelerating the truck, but he was unable to operate this. The reason was that the pneumatic system malfunctioned which had not only caused the brakes inoperable but also deterred the use of the gears. The air horn of the truck was also unusable for the same reason.

Afterward and until the collision, the truck driver tried to maneuver the vehicle on the roadway and avoid collision with other vehicles on the road. He also tried to alert other vehicles' drivers by shouting, hand waving, and clapping on the vehicle door. Two passengers of the truck were very scared at the time and decided to jump out of the vehicle and then they got injured. When the truck approached the curve presented in Fig. 3, the truck had its highest speed and rapidly reached a passenger car. As could be seen in Fig. 4, the truck driver intended to overtake the car, however, due to another truck coming in the opposite direction, it was unable for him to deter a collision between his truck and the passenger car in front.

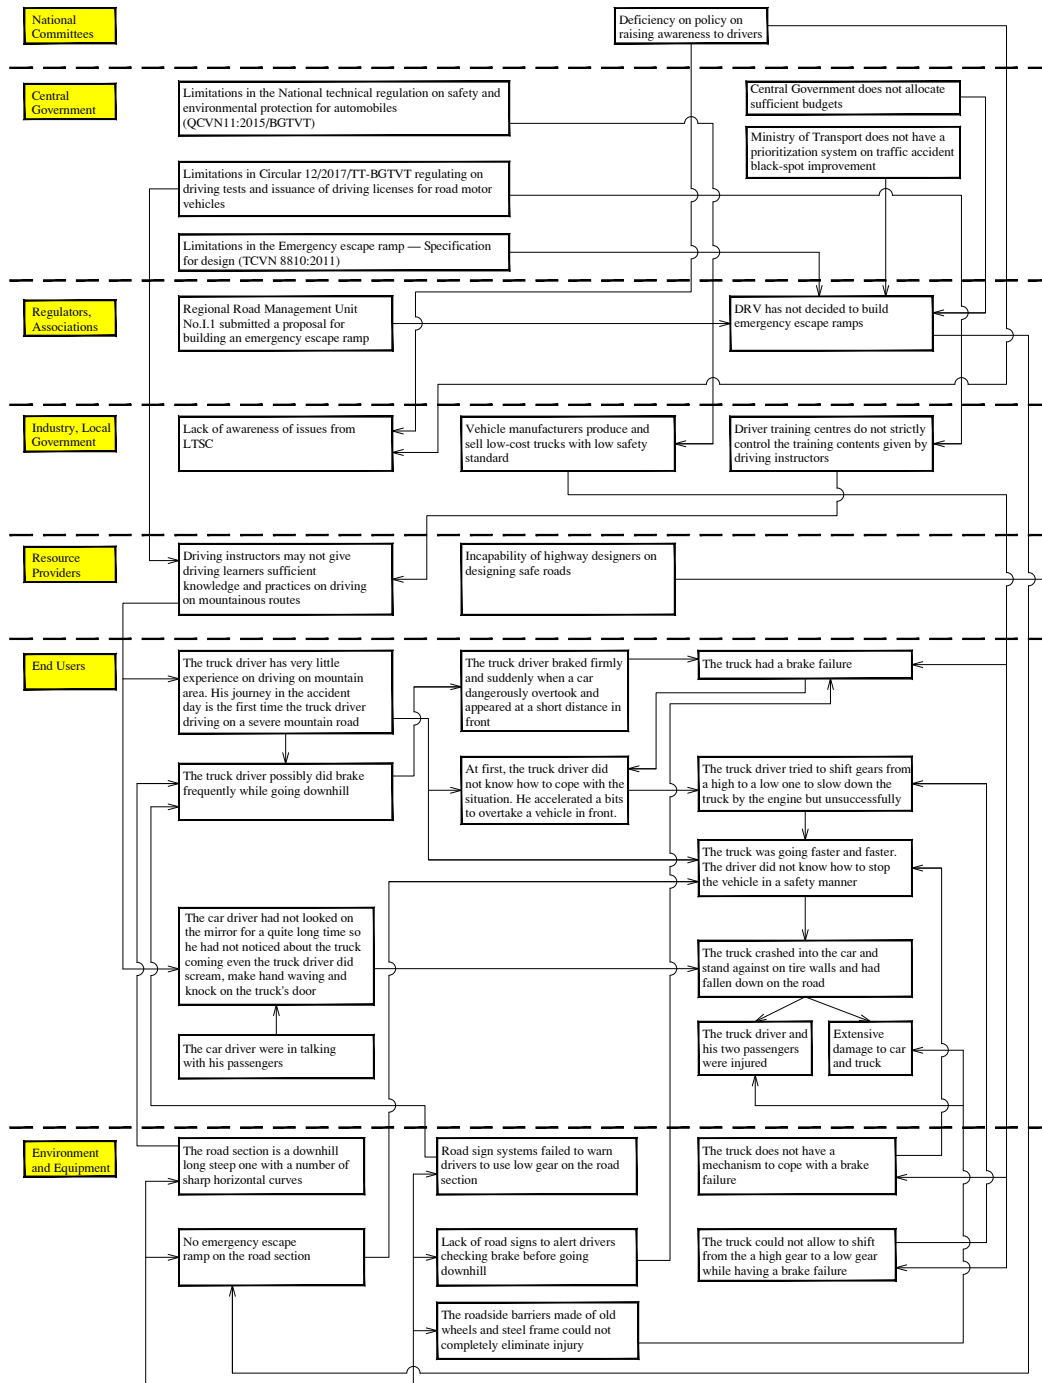
Figure 5. Accimap for the accident under study

As presented in Fig. 5, at the bottom level, Environment and Equipment, roadway and road sign characteristics, roadside safety barriers, and truck characteristics are factors contributing to the crash and its consequences. As described above, the downhill road section is steep and long with a lot of sharp horizontal curves. These conditions increase the risk of having a brake failure or losing control,

given the additional physical stresses placed on the vehicle's components. Emergency escape ramps are often used as a traffic safety countermeasure for such mountain road sections; however, no such emergency escape ramps existed on the road section under analysis. If there was an emergency escape ramp between the points where the truck brake failure was first recognized and the crash location, the accident may have been averted. Regarding road signage, there were several signs posted to warn the driver of the steep downhill road section. Although signs with a message of "slow down and use low gear when going downhill" are posted at some locations, the signage system seems to have failed to sufficiently alert the driver to the dangers of the driving environment. There is no sign to suggest to drivers to check their brakes while going downhill, a limitation that would be easily addressed. Interestingly, the truck driver said that he did not notice the signs, and as such did not consider using low gears while on the downhill road section.

The End Users level shows the contribution of the truck driver and car driver to the accident, as well as the sequences of events leading to the accident. The combination of the truck driver's inexperience and lack of knowledge and skill in driving on mountainous roads played a significant role in the accident. In the interview with this paper's authors, the truck driver stated that he did not remember how much he had used brakes before the incident, but that he believed he had used brakes in a normal way, i.e., used as necessary, without considering the possibility of having a brake failure. If the driver had been made more aware of this possibility, he might have tested the brake frequently rather than only using it firmly and suddenly when conditions immediately called for it. After realizing that the brakes were not functioning, the truck driver lacked the knowledge and experience to properly cope with the situation. He said that at the time he noticed the brake failure his truck speed was not high, at around 40 km per hour. At that time, given the relatively low speed, it may have been possible, even without the pneumatic system working, to have changed from the high gear to a lower one. Later the truck driver tried to change the gear, however, the truck mechanism did not allow the change when the truck was at high speed at that time.

Regarding the car driver, he acknowledged that he did not frequently look in the mirror while driving on the route that day and that at the time of the crash, he was talking with his passengers. It should be noted that the truck driver had tried to alert other road users by shouting, hand-waving, and knocking on the truck's door. If the car driver had been looking frequently in the mirror, he might have noticed the abnormal behavior of the truck and acted accordingly in response.

There are two factors that driving instructors and highway designers were included in the level of Resource Providers. Driving instructors may be partly responsible for not giving driving learners sufficient knowledge and practice on driving on severe mountain roads. Highway designers may partly

At the level of Industry and Local Government, several factors influencing the crash have been identified, including; Local Traffic Safety Committee (LTSC), vehicle manufacturers, and driver training centers. With regards to the LTSC, a number of similar accidents at the site had happened before the study accident occurred; however, the LTSC did not have a strong voice on the issue, failing to urge relevant organizations and authorities to have appropriate responses. Vehicle manufacturers have the responsibility of producing and selling low-cost trucks with low safety standards. Driver training centers contribute indirectly, through driving instructors, to drivers' insufficient knowledge and practice of driving on mountain roads; it is commonly known in Vietnam that they often do not strictly supervise their instructors regarding the contents of driving lessons.

Only one actor was identified at the level of Regulators and Associations, the Directorate for Roads of Vietnam (DRV). This organization has the power to propose and select traffic safety improvement projects; however, despite a proposal to build an emergency escape ramp submitted by the Regional Road Management Unit No.1 (which is an organization working under the DRV), the DRV has not made a decision to build the ramp, giving budget constraints as justification.

At the central government level, the limitations on standards and regulations, budgetary constraints, and a lack of prioritization of road safety improvements are contributing factors to the accident. Three regulations and standards in particular were found to be relevant to the accident. Firstly, the national technical regulation on safety and environmental protection for automobiles (QCVN09:2015/BGTVT) issued by the Ministry of Transport [19] does not stipulate the requirements of, and testing methods for ensuring vehicle brakes work well even after traveling down steep downgrade sections such as that under the current examination. If this deficiency is improved, vehicles with safety standards like the truck in the crash would not be approved to be used. Secondly, the Ministry of Transport issued Circular 12/2017/TT-BGTVT regulates driver training, driving tests, and issuance of driving licenses for road motor vehicles [20]. This circular does not force learner drivers to practice driving on mountain roads or require driving license candidates to drive in such environments during testing. These limitations contribute to the fact that the truck driver in the accident lacked experience and skill in such circumstances. Thirdly, there are no explicit criteria for a requirement for building emergency escape ramps stipulated on the technical standard of "Emergency escape ramp – Specification for design" (TCVN 8810:2011) [21]. This shortage accompanied by budget restrictions and the lack of a prioritization system for improving traffic accident black spots is the essential reason why the postponement of the DRV on constructing an escape ramp had occurred.

Deficiency in policy on raising awareness of drivers is identified as the only factor at the top level of national committees. It is a fact that in Vietnam up to date, there has been no issued policy by the National Traffic Safety Committee stipulating the requirements for local governments and other relevant organizations to raise public awareness of traffic safety problems.

Based on the Accimap model, therefore, recommendations for traffic safety interventions at different levels on the Accimap model were made. These are summarized in Table 1. The following are several key potential areas for reducing the likelihood and severity of downgrade truck collisions on a mountainous road in Vietnam.

First, since the truck driver's inexperience and lack of skill in driving on a severe mountain road could be considered as direct causes of the crash, Vietnamese drivers should be well educated and trained in order to reduce such types of accidents. To do this, the driving training curricula should include an explicit requirement to experience driving in a variety of different road environments. The operation of driver training centers should be strictly monitored, and they should be required to strictly force driving instructors to give driving lessons that conform to the curricula. In addition, given the significant number of mountain roads in Vietnam, the content of the driving test should include the testing of relevant driving skills in these environments.

Secondly, improving road infrastructure is definitely a way to prevent downgrade truck collisions and reduce their consequences. In the case of the truck crash under the current study, improvements in various road features, such as road sign systems, roadside barriers, road alignment, and emergency escape ramp (see Table 1), would have enhanced road traffic safety. To facilitate this, several things should be done at the upper level of the Accimap (see Fig. 5). First, it is necessary to enhance the capacity of highway designers in designing a safer road system. In addition, a sufficient budget for traffic safety improvement should be allocated and a reliable prioritization system for selecting traffic accident black-spot improvement projects should be developed. Furthermore, the technical standard of "Emergency escape ramp – Specification for design" (TCVN 8810:2011) should be revised in which the criteria for a requirement of building an emergency escape ramp should be clearly specified.

Thirdly, the quality of the vehicle was also a concern. Despite the truck in the accident being quite new (it was bought as new and started entering into operation in 2015), its braking system was not suitable for some road environments. In addition, as aforementioned the truck did not have a mechanism to cope with a brake failure, with failure of the pneumatic system also rendering impossible the changing from a high gear to a low. Therefore, the Ministry of Transport of Vietnam is recommended to revise the National technical regulation on safety and environmental protection for automobiles (QCVN09:2015/BGTVT) which describes the requirements and testing methods that ensure vehicle brakes are able to work well in all environments reasonably expected to be experienced when driving in Vietnam.

Lastly, more efforts should be put into raising public awareness of the issue of downgrade truck collisions and reinforcing the cooperation between different stakeholders to quickly respond to traffic safety issues including the crash under analysis above. As shown in Table 1, NTSC should issue a strong policy to facilitate raising public awareness of these specific traffic safety issues. In addition, NTSC and LTSC need to be given powers to force relevant organizations to quickly solve the identified traffic safety problems. Furthermore, road authorities such as the DRV should be required to quickly propose and implement traffic safety improvement projects, reacting to the voice of local government and the public.
