# AN EXPERIMENTAL STUDY ON FLEXURAL BEHAVIOR OF CORRODED REINFORCED CONCRETE BEAMS USING ELECTROCHEMICAL ACCELERATED CORROSION METHOD

## **Abstract**

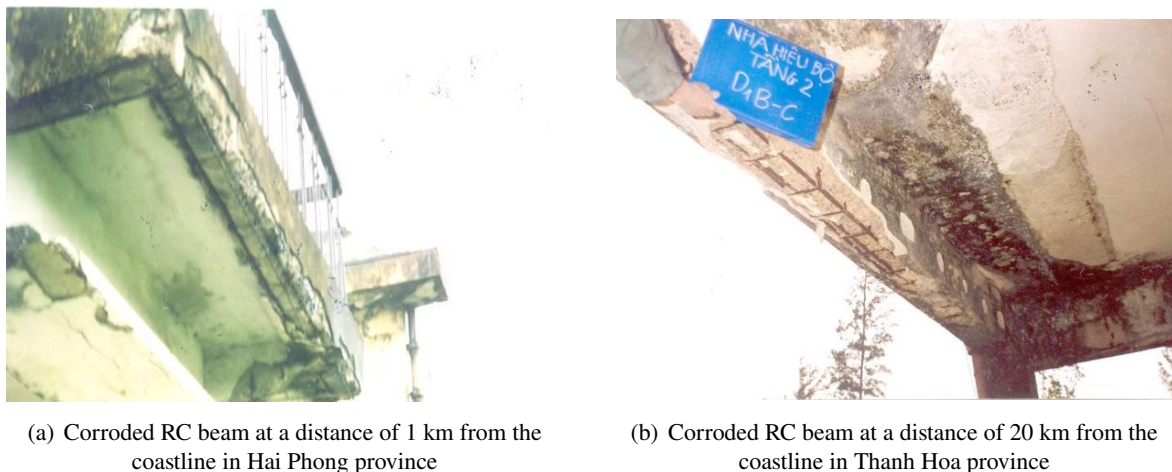
Figure 1. Reinforcement corrosion in existing corroded structures [19]

The data collected shows that the frequency and the cost of work repair for damage and degradation caused by corrosion has been increasing [17]. In Japan, a study indicated that 90% of existing RC structures have been exposed to the marine environment with protection concrete layer been not large enough and only 10-year-old works damaged are accounted for a large proportion. In the United States, based on the track of 586000 highway bridges, 15% of them have damaged structures, primarily due to aggressive corrosion. Vietnam has a very long coastline and major cities are not far away from the coastline. In our country, many coastal RC structures built from the 1960s to now have been applied building codes with little attention to the requirements for protection against corrosion under TCVN 9346:2012 [18]. In Vietnam, the effects of corrosion are more apparent than in other countries in the world, due to climatic conditions, temperatures, high humidity, large wet periods, high chloride ion concentration. Many works are severely affected by the corrosion process after a short time of use. Fig. 1 illustrates the severe corrosion situation of some existing RC structures in Vietnam [19].

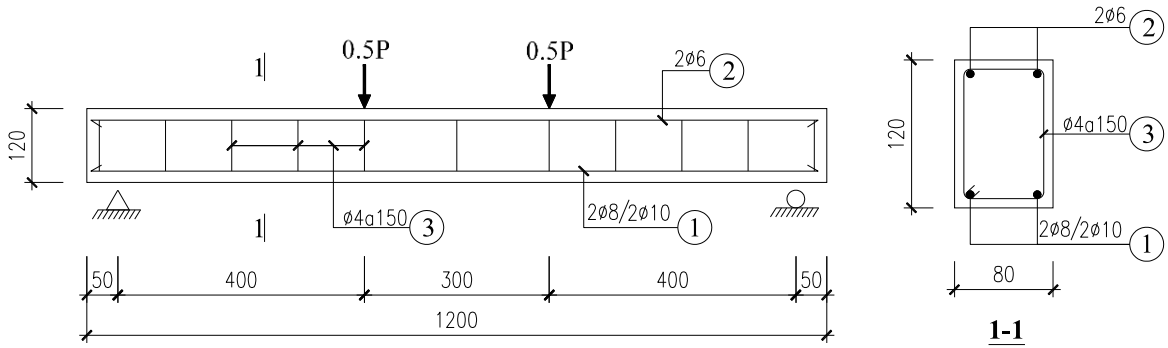
Figure 2. Dimensions of D8 and D10 testing beams

There are six testing beams were divided into two groups that were cast with the details shown in Fig. 2. These beams were made has cross section of 80 × 120 mm (width × length); the concrete protective layer is 15 mm and the beam length is 1200 mm. There was 2D6 steel bars on the top side for hanging purpose. The rectangular stirrups No. 3 in the section 1-1 were D4a150 along 400 mm segment at two ends and D4a300 at the mid-span segment. The stirrup was plain bar. The difference between the two groups was the two longitudinal reinforcing bars at the bottom (No. 1), which were 2D8 deformed bars and 2D10 deformed bars for Groups 1 and 2, respectively.

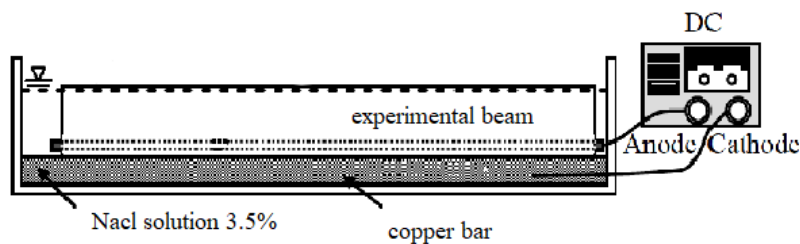
Figure 3. Accelerated corrosion setup

After curing the experiment samples for at least 28 days, the reinforcement was induced corrosion by electrochemical accelerated corrosion methods. The two beam samples in each sample group are corroded, named D8-2, D8-3, D10-2, and D10-3. Two remaining beams (named D8-1 and D10-1) are not corroded and will be used as control beams. Fig. 3 illustrates the electrochemical accelerated corrosion method. The longitudinal rebars (D8 or D10) of the testing samples were connected to the anode of a DC power supply. The cathode of the DC supply power was connected to a copper bar placed in NaCl solution of 3.5% concentration (35g NaCl in 1 liter of water). With this NaCl content, salt water has the salinity equivalent to that of seawater in Vietnam and in the world, and in the experiment, it served as the electrolyte solution. The DC power supply allows converting alternating current into direct current. In this experiment, a voltage  $U = 5 \text{ V}$  was maintained stability during the implementation of electrochemical corrosion. The maximum period of electrochemical corrosion testing was 14 days (336 hours) for D8-3 and D10-3 beams.

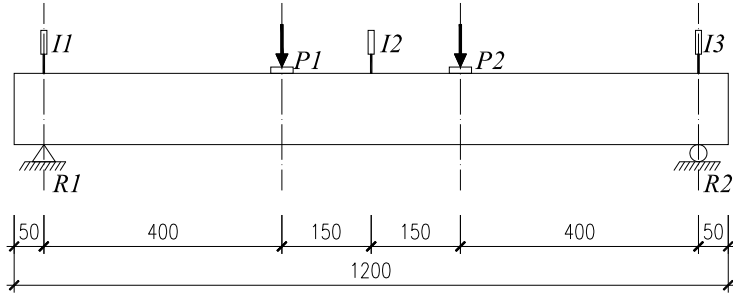
(a) Diagram of 4-point bending test

After electrochemical accelerated corrosion of corroded beams and after curing for at least 28 days with non-corroded beams, the testing samples were subjected to monotonic loading to investigate their performance. In the test, the 1200 mm-length specimen was singly supported over a span of 1100 mm and was subjected to two symmetrical concentrated loads at points  $P1$  and  $P2$  which were both at a distance of 400 mm from the supports  $R1$  and  $R2$ . The loads were generated by means of a

hydraulic jack and an oil pump by hand. A load cell was used to measure the load applied during the test. Three Linear Variable Deformation Transducers (LVDTs) were installed to measure the vertical displacement of each tested beam. The sets of displacement transducers ( $I1$  and  $I3$ ) were used to measure the displacement at the supports ( $R1$  and  $R3$ ), respectively. The  $I2$  displacement transducer was used to measure the displacement at mid-span of the beam. All displacement transducers were connected to a TDS-530 data-logger and a computer to collect automatically measurement data in order to establish the relationship between applied load and displacement. Fig. 4(a) shows the loading diagram and arrangement of the measuring instruments.

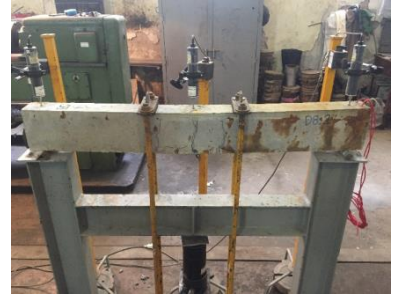
(b) Photo of testing beam

Fig. 4(b) shows a photo of the bending test on a typical beam. During the experiment, the applied load was continuously increased until the beam failed. At the same time, each testing beam was observed carefully to detect the appearance of the first concrete cracking. The development of concrete cracks was highlighted on the testing beam surface. After the end of the experiment, the distance between the concrete crackings was measured for the tested beams.

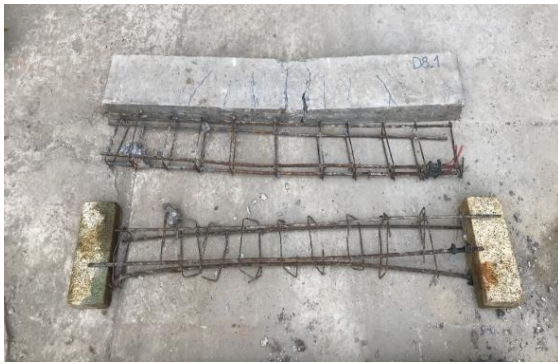
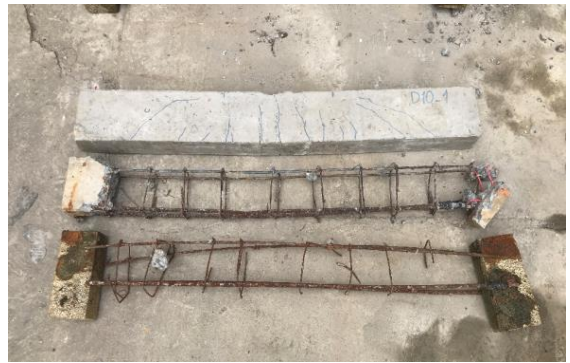
(a) Group 1 of D8 beams

(b) Group 1 of D10 beams

Figure 5. Overview of non-corroded beam and reinforcements corrosion rate of corroded beams

Fig. 5 shows the reinforcement photos after corrosion of the testing beams. It can be observed that

all rebars are along the upper layer, the lower layer, and the stirrups were also corroded. The pitting corrosion was also observed for both the longitudinal bar and the stirrup. Especially, in the corners of the stirrup, it is shown at the degree of localized corrosion is higher (pitting corrosion) than at the other positions of the stirrup, as can be seen in Figs. 6(a) and 6(b). This was also observed in experiments on the corrosion made by [14, 15, 25]. Four corroded specimens did not display significant visible cracks. According to Uomoto and Misra [26] cases have been reported in which no visible cracks appear on the concrete surface despite severe corrosion of the reinforcement, especially when the diameter of the bars is less than 16 mm. In this study, maximum diameter of reinforcements has a diameter of only 10 mm, explaining why no visible cracks were found for D8-2, D8-3, D10-2, and D10-3 tested beams.

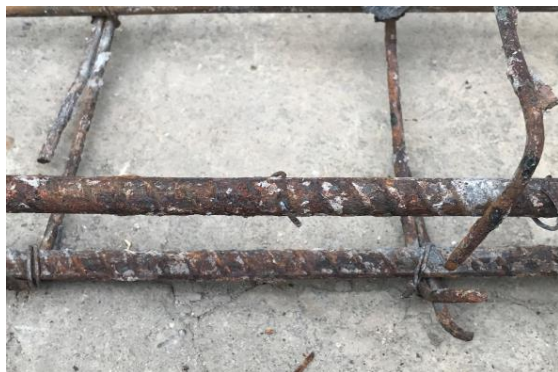
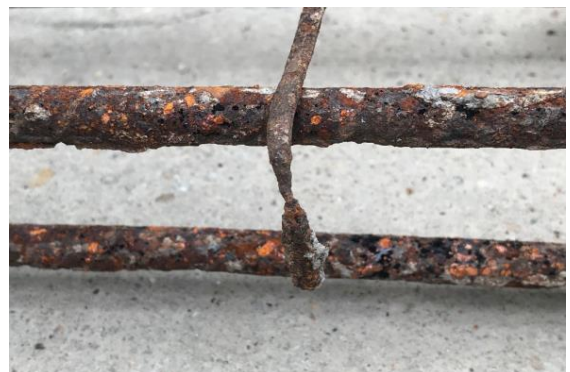
(a) Corroded steel bars in D8-2 beam with  $c = 7.5\%$

(b) Corroded steel bars in D10-3 beam with  $c = 14.1\%$

Figure 6. Close view on corroded steel bars

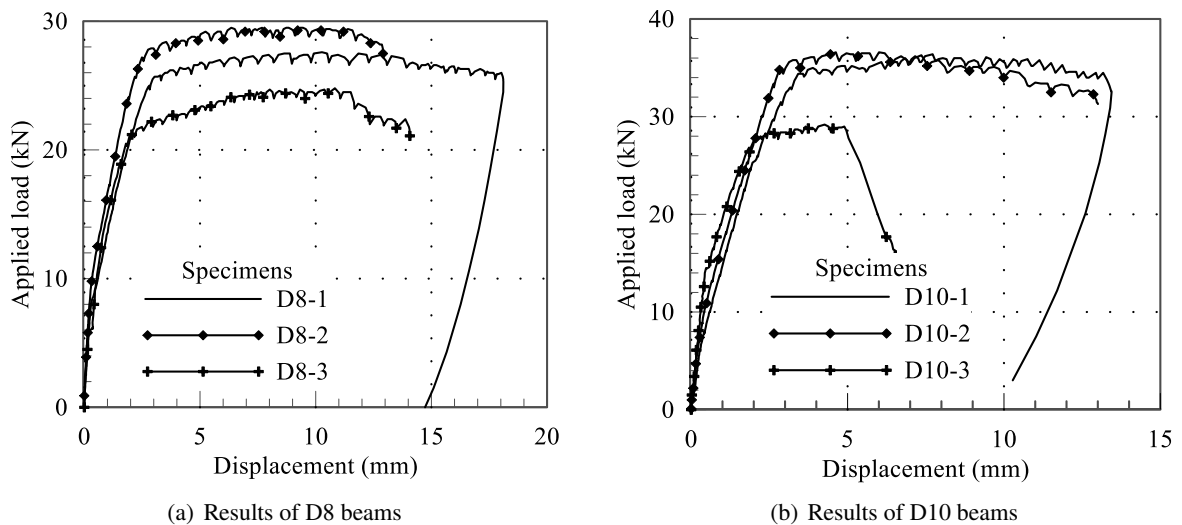
Figure 7. Load versus displacement for testing groups of D8 and D10 beams

Figs. 7(a) and 7(b) show the response for testing groups of D8 and D10 beams, respectively. The control beams and corroded beams exhibited a typical flexural failure mode, as evidenced by the clear softening of hysteretic behavior before failure and no significant inclined cracks and/or fracture of stirrups were observed in the tests. The flexural cracks developed first on the bottom face of the specimen and propagated deep into the section as the displacement increased. When the concrete spalled, the flexural strength dropped drastically and hence the test was terminated.

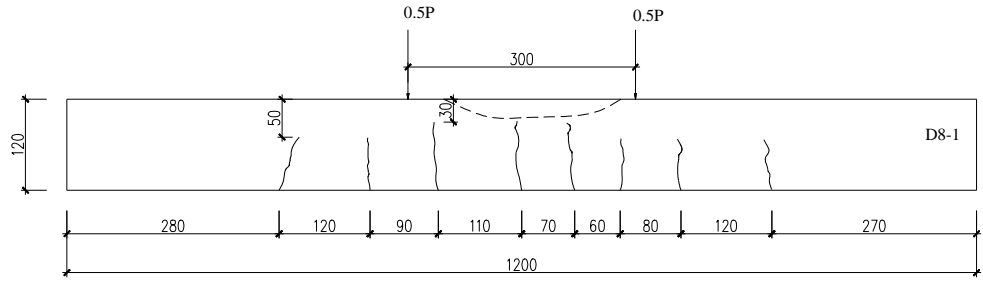
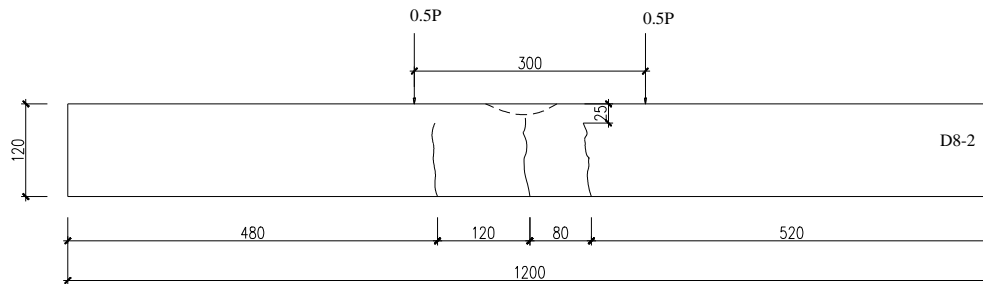
(a) Cracks distribution on the D8-1 beam

(b) Cracks distribution on the D8-2 beam

Figure 8. Comparison of the distribution of concrete cracks on D8 testing beams

At the end of bending test, the length and spacing among the concrete cracks were measured and highlighted in Figs. 8 and 9. It is found that the number of concrete cracks on the non-corroded beams is more than that of corroded beams. Furthermore, crack spacings on the non-corroded beams are smaller than that of corroded beams, and the width of cracks on the corroded beams are generally larger than that of non-corroded beams. That is because reduction of bond reduces the ability of the section to mobilize the strain in the steel bars. The section must rotate more to yield the longitudinal reinforcement. Concrete capability to share tension from reinforcement (tension stiffening) is decreased due to bond reduction, subsequently decreasing the number of crack appeared in the beam and enlarging the width of the crack on the corroded beams.

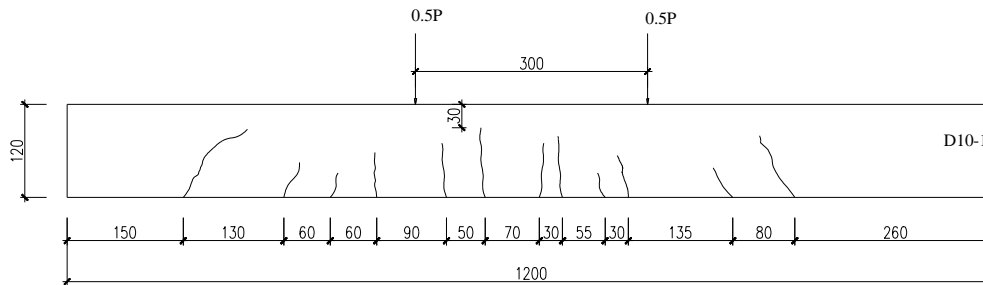
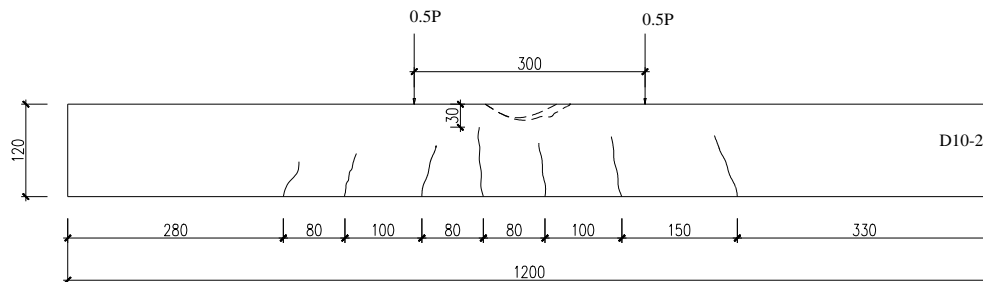
(a) Cracks distribution on the D10-1 beam

(b) Cracks distribution on the D10-2 beam

Figure 9. Comparison of the distribution of cracks on D10 testing beams
