# AN ANALYSIS OF CAUSES TO DAMAGES FOR RURAL ROADS IN THE NORTHERN MOUNTAIN REGION OF VIETNAM AND AN ORIENTATION TO SOLUTIONS

**Summary:** This paper is to conduct analyses of root causes to typical damages and losses to rural roads in the Northern mountain region of Vietnam; on such basis, to recommend guidance to solutions. The results from this study have shown that there are many different types of damage occurred on different components of rural roads. These damages are often associated with defects in various implementing phases including: rural road planning, design, construction and operation and maintenance. The findings in this study can be used as a basis for developing countermeasures to enhance the sustainability of rural roads in the Northern mountain region.

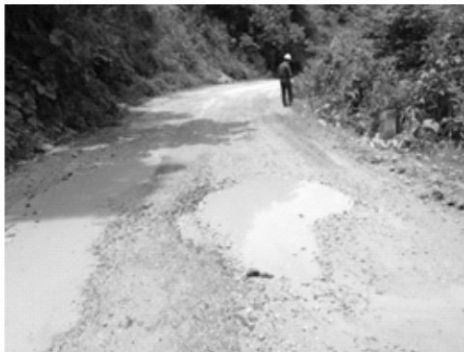
The second cause to damages of road surfaces is inadequate drainage system which leads to the water runoff flows freely on the road surface and spill up over the drainage system (Figure 3). The penetration of surface water on roads reduces the strength of road bases and pavement structural material layers, which deteriorate road surfaces when vehicles pass through. Site observations show that on the same road, the locations where road surfaces are frequently wet will be those at which damages of road surfaces occur first.

a. Road surface is peeling off, cratered due to frequent concentration of water

One of the reasons to the poor condition of the current drainage system all over the local roads as found is due to lack of regular maintenance. Culverts, ditches are generally congested with full of mud, plants... leading inefficient operations. In addition, improper design was also leading to long lasting, moisture saturation roadbed and surfaces. On several roads, water runoff in ditches overflows on road surface upon heavy rain. Most of the ditches are unpaved ones causing severe erosion in the ditches' base.

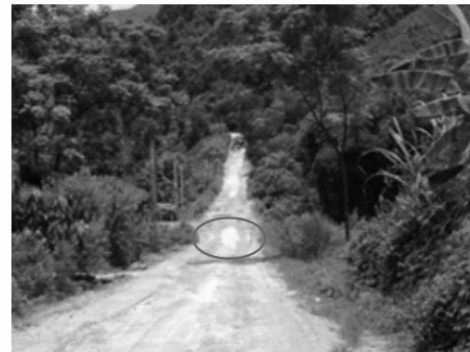
b. Water concentration at lower points on road surface (marked area)

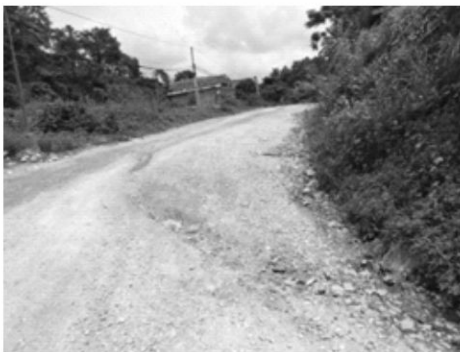
Beside the general causes such as heavy loads, poor compaction or improper maintenance, this type of damages is elementary caused by overflows on road surface at high speed. This problem frequently occurs in road sections with high longitudinal slopes when the side ditch system doesn't work properly, causing runoffs to concentrate on road surface.

a. Runoffs acrossing road surface cause erosion

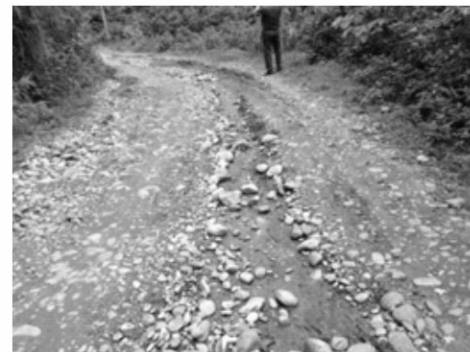
The secondary cause is the usage of improper types of materials. In fact, the aggregate material types used for construction of rural road surfaces are partly naturally exploited materials with bad quality. An example shown in Figure 4 illustrates the aggregate materials include granular particles with sizes exceeding the permitted level.

b. Surface course materials are eroded and washed away

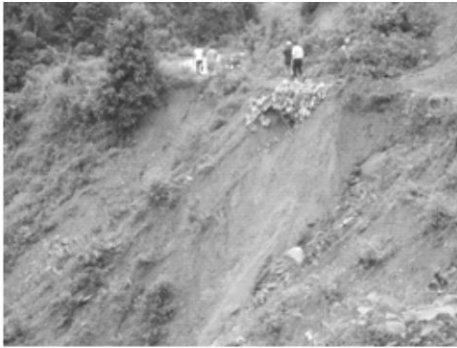
This phenomenon frequently occurs in the places of the filled road base on steep slopes with major horizontal gradient as illustrated in Figure 5. Under forces by loads of filled soil volume, the fill-slope itself may be slid or both filled base and natural steep slope are slid, causing damages. Another type of damaged filled road base on steep slopes is caused by minor friction between filled soil and natural steep slope, leading to slides of filled portions on natural steep slopes. Therefore, the usage of high filled based on steep slopes is not recommended, especially for slopes with high gradient due to high risks of slope instability. There are many causes to slides of filled bases on steep slopes.

a. Slides at both cut slopes and fill slopes

From the perspective of road design, this type of damage doesn't occur if the horizontal alignment is selected well. In many cases, a wise selection of alignment and appropriate profile design will dramatically reduce the usage of filled base on steep slopes, thereby reducing risks of instability of filled slopes. Besides, very few design proposals of rural roads carry out detailed checking of stability of fill slopes on steep slopes.

During construction stage, the compliance of quality of road base compaction for filled portions on steep slopes with major gradient is not focused properly. Through discussion with local authorities, upon the construction of types of filled bases on steep slopes, the fill materials are extracted from cut materials of cut bases and then graded into filled bases with high elevation. Thus, the fill materials are not selected carefully and fail to meet requirements for fill materials. Moreover, this filled portion is not compacted to ensure the required compactness within the scope of whole soil base volume (generally meet the required compactness for soil layer above filled portion). The compactness of roadbeds is not ensured, which means the load bearing capacity of filled base fails to meet the design requirements.

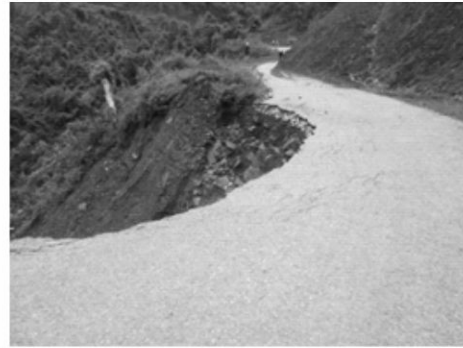
b. Close look at slides of fill slopes

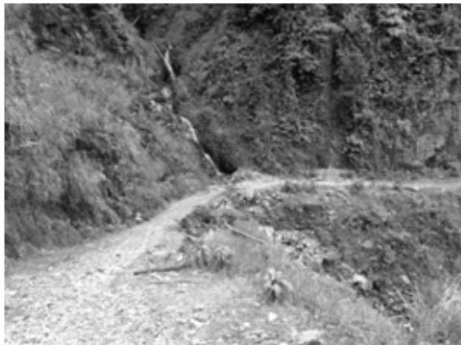
In addition to non-compliance of compaction requirements, fill slopes on steep slopes are not usually protected carefully, leading to storm water's overflowing on slope surface. At points where runoffs concentrate on fill slopes, the storm water easily penetrates into loosely compacted soil base, hence quickly reducing the load bearing capacity of slopes; as a result, the slopes are damaged. In addition, observations at many locations of slides of fill slopes on steep slopes show that in many cases, the grading and organic excavation before filling are not carried out in accordance with regulations, reducing frictions between filled base bottom and natural steep slope. The penetration of storm water into adjoining surface between filled base bottom and natural steep slope increases the risk of slides of filled portion on steep slopes (see Figure 6).

a. Runoffs across roads (due to no horizontal culverts) causes slides of fill slopes on steep slopes

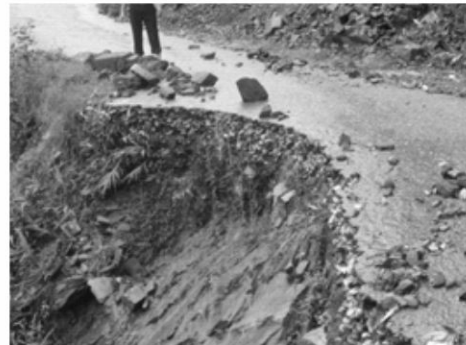
b. Slides of filled portion on steep slopes with major gradient due to overflows on slopes and weak friction between filled portion and steep slopes
