# EXPERIMENTAL STUDY ON THE BEHAVIOR OF ECCENTRICALLY COMPRESSED CORROSION-DAMAGED REINFORCED CONCRETE COLUMNS

This paper presents an experimental study of corrosion-damaged reinforced concrete (RC) columns under eccentric compression. Three RC concrete column specimens, identical in geometry, reinforcing steel bars, and concrete mix, were fabricated. One undamaged control specimen served as the control group, while the other two column specimens underwent corrosion due to chloride ion exposure. All specimens were subjected to a minor eccentric compressive load. The test results have revealed the behavior of RC columns damaged by steel corrosion. Additionally, a comparison of the load-bearing capacity of corrosion-damaged RC columns was conducted between calculation and experiment. The results indicate a close alignment between calculated and experimental outcomes. Furthermore, the degree of decrease in the load-bearing capacity of corrosion-damaged RC columns over time was evaluated based on the axial load-moment interaction diagram. This evaluation considered the influence of the reduction in concrete strength and the cross-sectional area of the reinforcement.

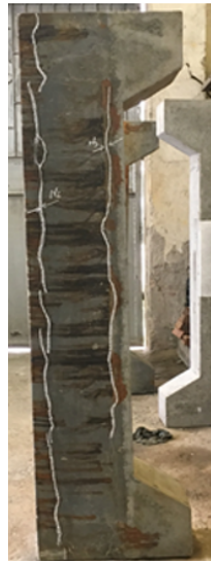
Figure 3. Illustration of surface crack on the test specimens C-C-1 and C-C-2

After conducting the accelerated corrosion test, two specimens were retrieved from the tank and left to air-dry. Following this, the distribution of cracks that had arisen due to the corroded reinforcement on the column surface was measured and depicted (Fig. 3). More details about the crack results can be found in Fig 6. Following the finishing of the compressive test, the corroded longitudinal bars were extracted from the test columns, cleaned of rust, and weighed to determine the weight loss resulting from corrosion.

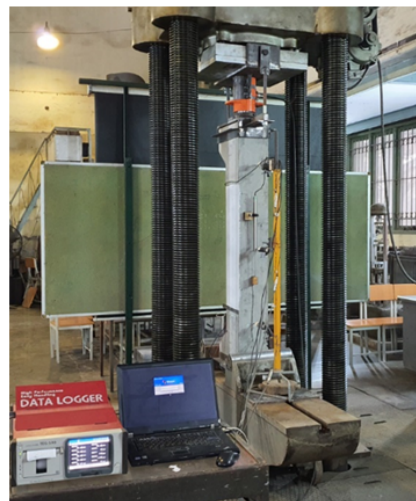
Figure 5. Image of a test in progress

Fig. 4 illustrates the eccentric compression test setup, while Fig. 5 shows a test in progress. Each specimen was tested under monotonically increasing eccentric load. A hydraulic actuator was employed to apply axial load to the test specimens. The upper ends of the test specimens were connected to the actuator, while the lower ends were supported by a steel reaction frame. Both of the end supports were designed as hinged connections, initially set with an eccentricity  $e_0$  of 30 mm, simulating columns experiencing minor eccentric compression. This eccentricity equals the distance between the applied load and the centroid of the column's cross-section in the test region. To ensure the lateral stability of each specimen, both in-plane and out-of-plane, suitable steel supports were used, as illustrated in Fig. 5.

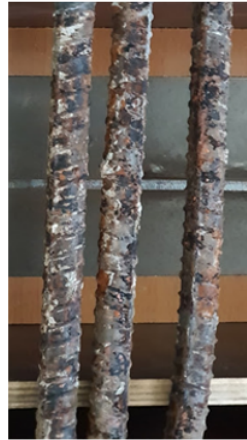
Fig. 7 depicts the rust condition observed on the longitudinal reinforcement steel bars, while Table 2 provides information on the weight loss resulting from corrosion. The values presented in Table 2 represent the averages of results obtained from two longitudinal reinforcement samples, each measuring 500 mm in length and extracted from the middle of the test specimen. With regard to stirrups, the measurement results indicate that stirrup corrosion averaged around 6.5% in the two test specimens C-C-1 and C-C-2.

Figure 7. Images of rust condition on the longitudinal steel bar

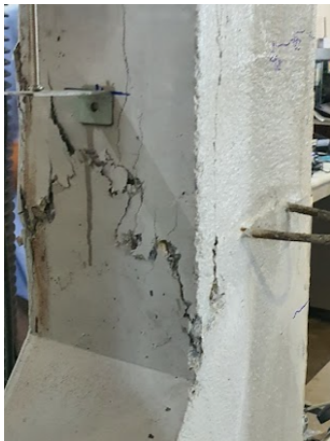
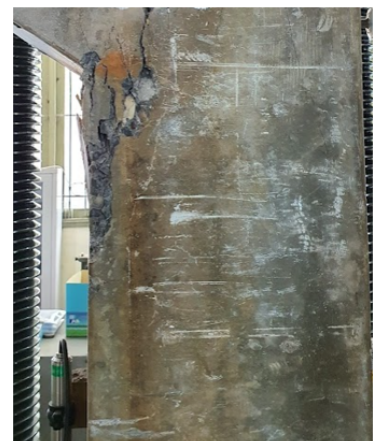
Fig. 8 illustrates the photos of the control and corroded specimens at failure, along with the corresponding failure regions. The failure mode for both the control and corroded specimens was typical. Cracks were observed in the compression zone, leading to a reduction in the bearing capacity of the test specimens. This mode of failure is suitable for cases with small eccentric effects.

Figure 8. Failure of tested specimens
